Livonia Maintenance Facility Case Study

Rejuvenating shops and facilities for the next generation of train fleets

NYCT Livonia maintenance facility

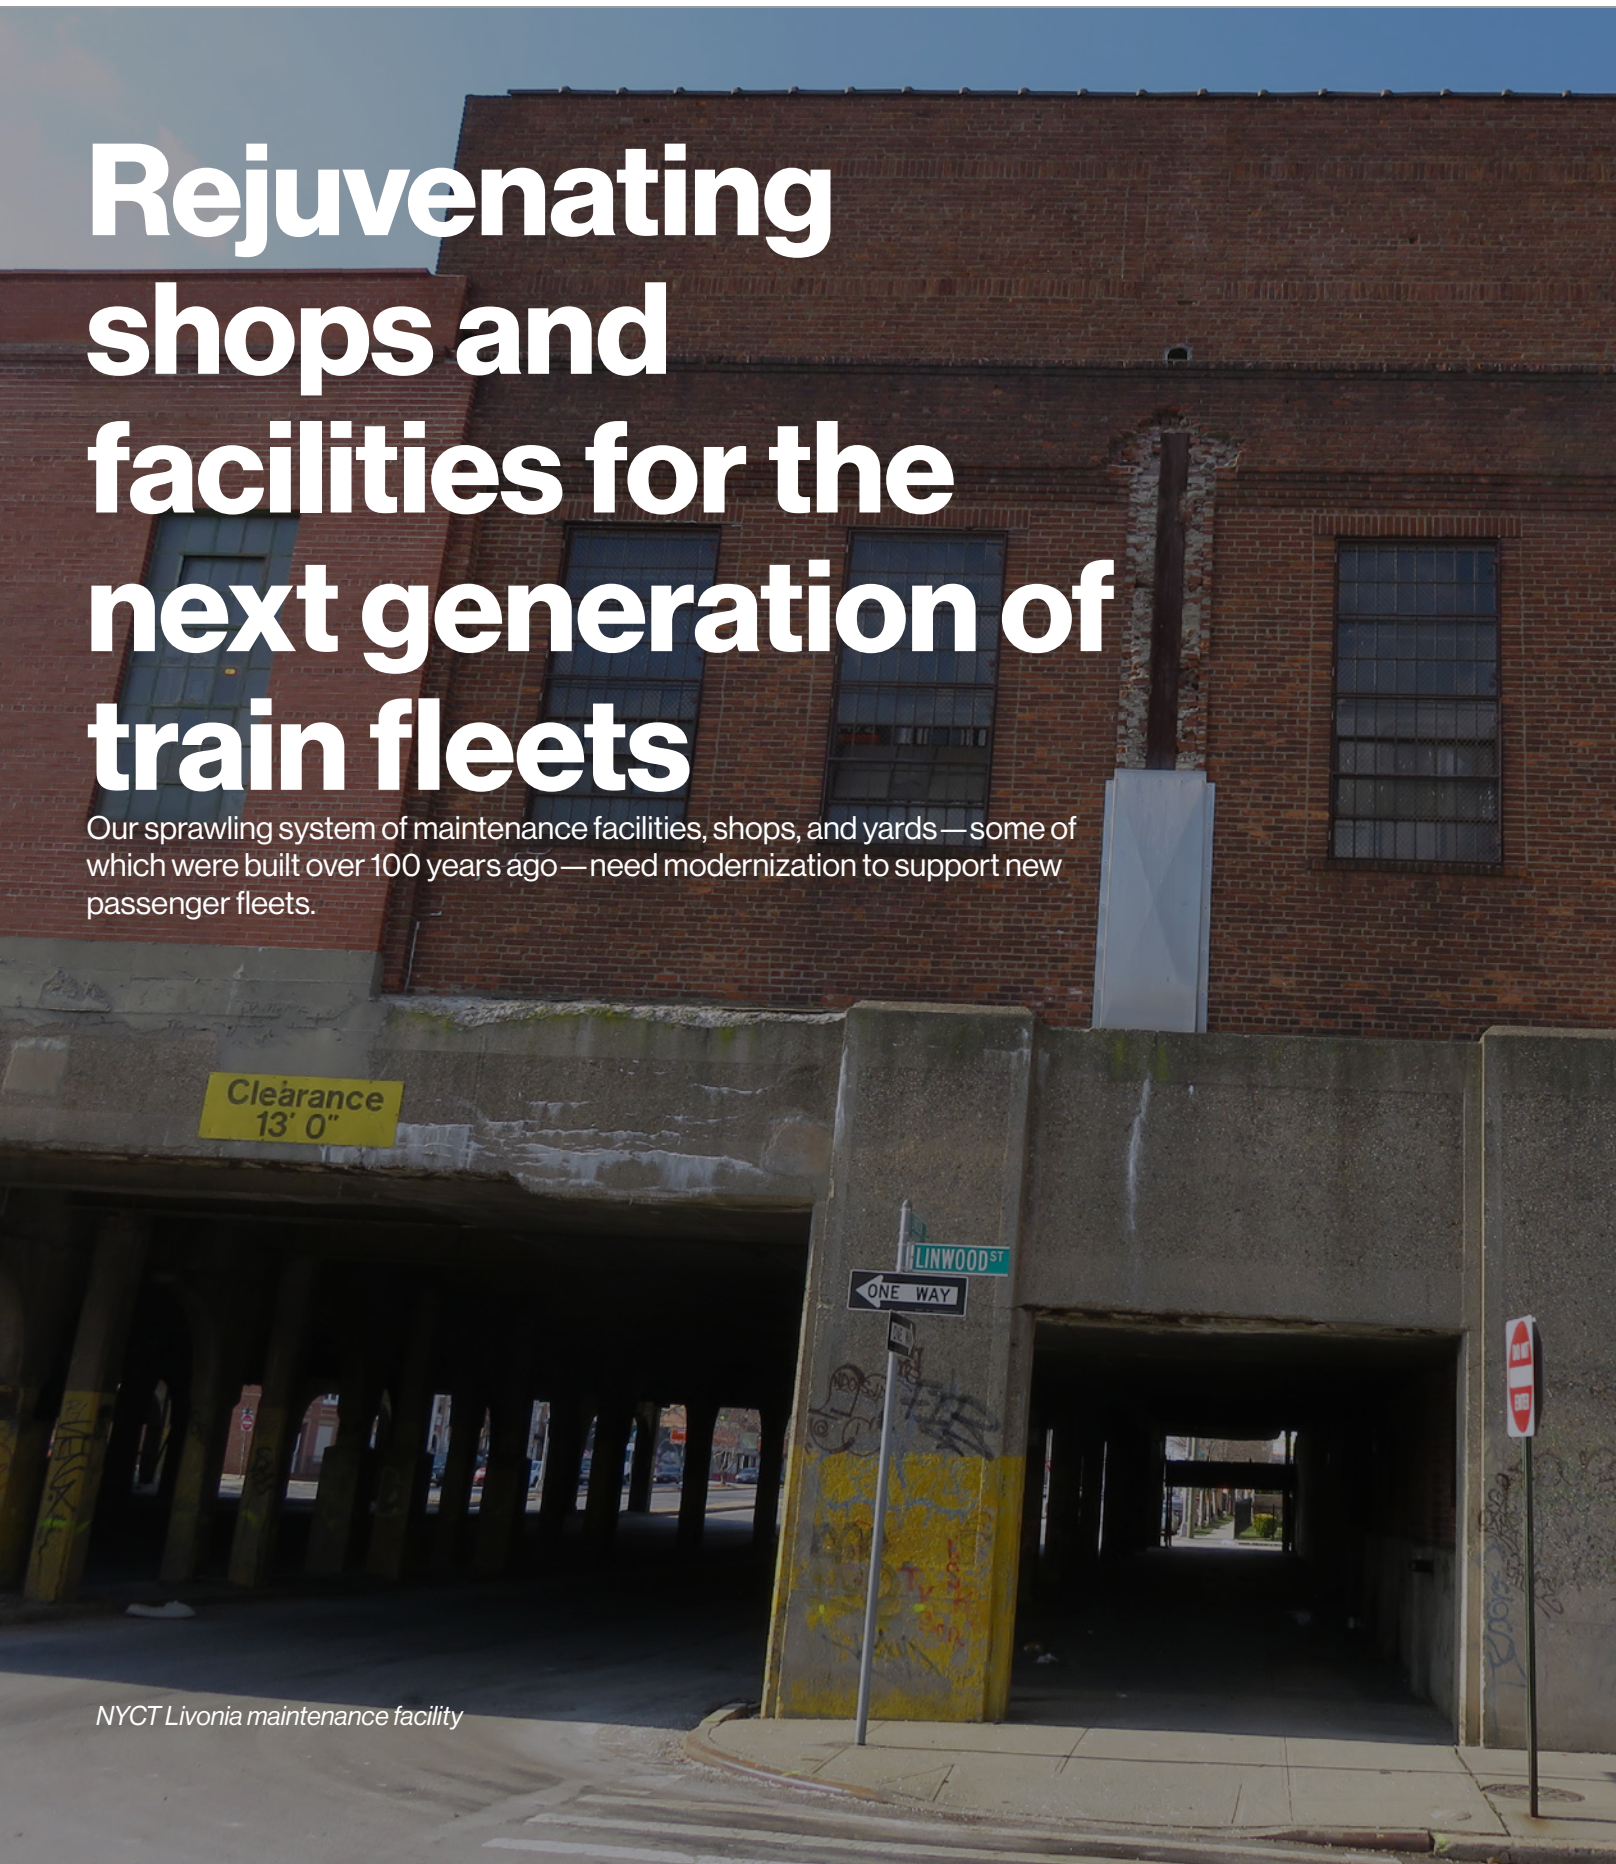
These conditions must be improved. Livonia was built to service trains in 1922. Since then, designs have changed—and the facility can't keep up. Our newest trains have roof-mounted air conditioning units, and with Livonia's low ceilings, we can't access them for maintenance. As a result, we are unable to replace any trains along the 3 line—even though all of the 2 trains have received more modern railcars.

The low ceilings and narrow aisles also restrict the use of cranes and the ability to move other equipment and trains around within the shop, forcing employees to inefficiently shift trains back and forth like a puzzle. The trenches underneath the trains are too shallow and cramped for our mechanics, requiring them to squat to do their work.

At Livonia, we're evaluating different design options which would either reconfigure or completely replace the existing facility.

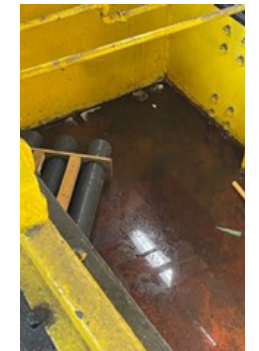
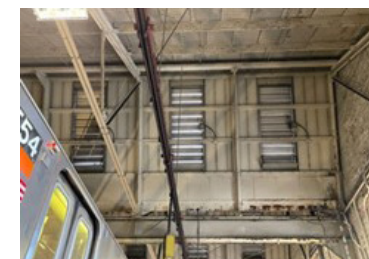
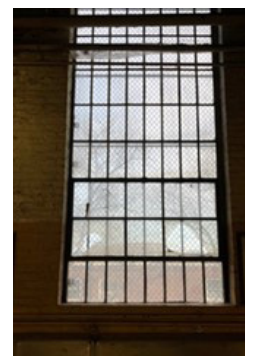
Instead, as you step inside the hulking brick building at Livonia, the walls are cracked and deteriorating. When it rains, water leaks through the roof then pools on the floor because several of the drains have collapsed or become too clogged to use. In the winter, a single boiler heats the facility and much of the warmth escapes through the holes in the walls and ceiling. Over the years, we have created additional makeshift bathrooms and locker rooms because the shop was built without facilities for women.

Livonia Shop in various states of disrepair

- » We must address all structural and component deficiencies.
- » We must add more administrative and employee space, including offices, workshops, restrooms, and locker rooms—for employees of all genders—to ensure the space is a safe and dignified facility for our staff.
- » We must install overhead cranes for removal and installation of HVAC units.
- » We must reconfigure the tracks, so our employees have sufficient space to work between railcars and to access side-mounted equipment on the cars.
- » We must minimize disruption. While we're doing this work, we need to ensure parts of the facility remain operational so that we can continue to service trains.
- » Finally, we must concurrently begin replacing the R62/R62A fleet.

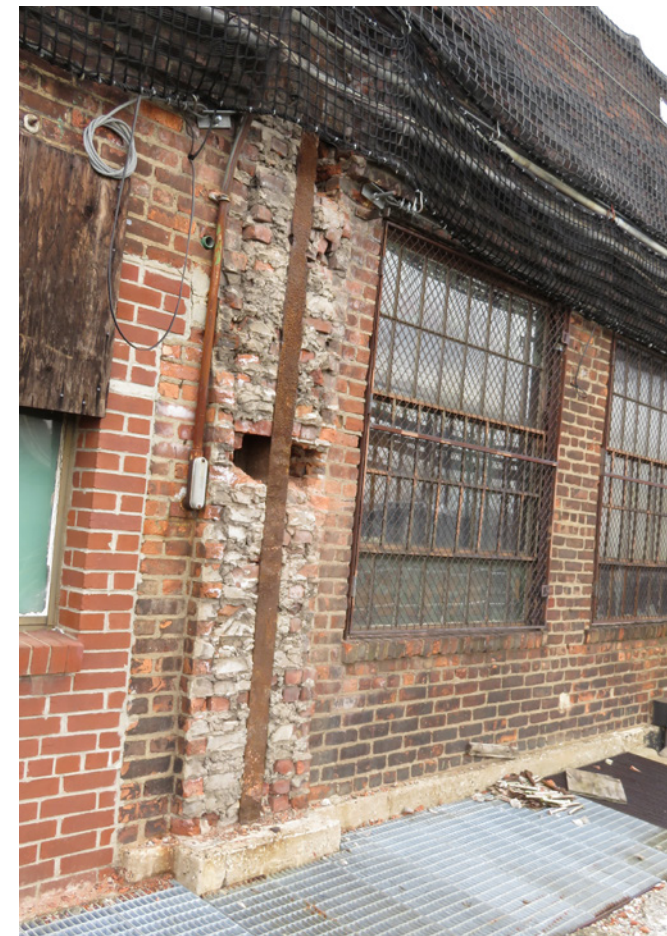
Crumbling exteriors at Livonia

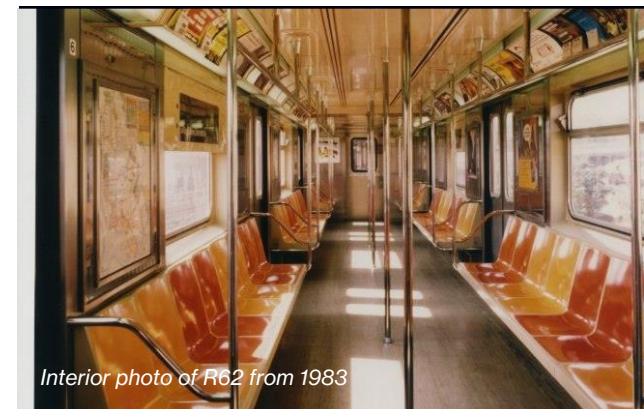
Interior photo of R62 from 1983

You might know the R62s as the railcars with the orange bucket seating. This is an interior shot of an R62 from 1983, the year they were introduced.

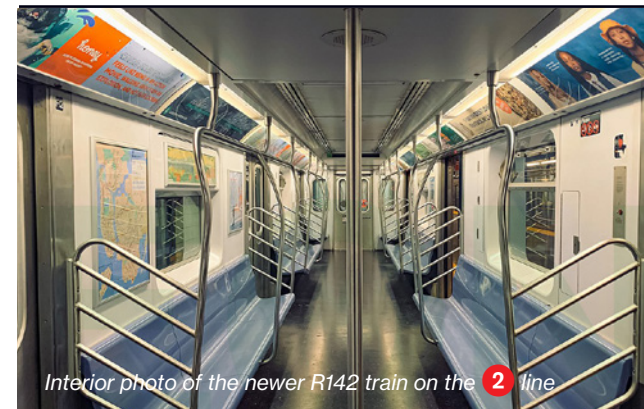
Interior photo of the newer R142 train on the 2 line

Newer R142 railcars on the 2 line feature brighter lighting, streamlined seating, upgraded HVAC, and digital route and destination signs.
